Conservation and Restoration Preliminary Report | April 2023

Wigginton Anti-Freezing Stand Pipes (Pumps)

Compiled by Spence Horton-Harpin on behalf of Wigginton Parish Council

Preliminary Report: Water Stand Pipes (known colloquially as Pumps)

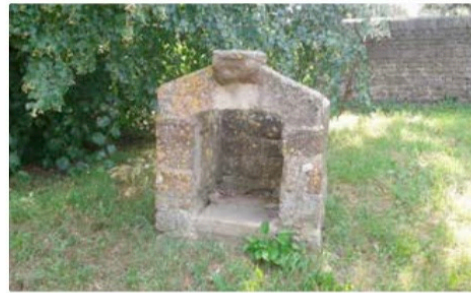
Well opposite St Giles Church

It is worth noting that the well head opposite St Giles Church is also afforded the same protection advice from the appraisal. Currently the left hand side towards the rear is falling away and the village risks losing this socially important remnant of the village within the conservation area. Repairs should be made by a skilled person using the correct materials (such as lime mortar etc.). Use of incorrect materials may cause irrevocable damage.

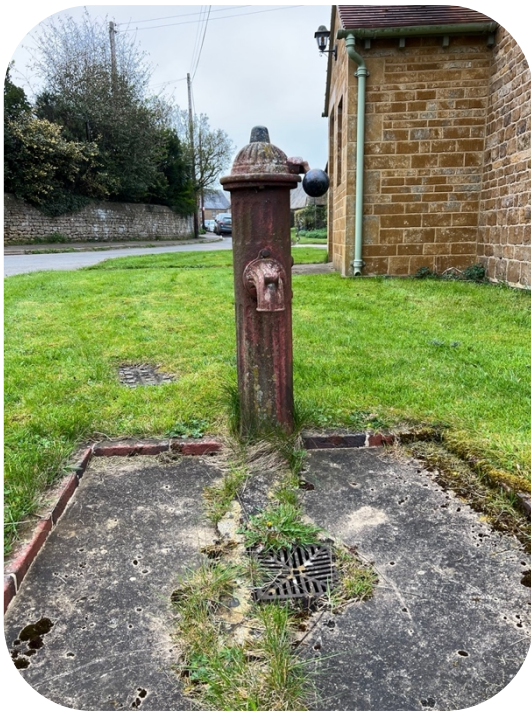
Outside Milton Cottage

Observations:

All parts were complete and apart from some surface rust, it was in good condition.

The stand pipe looks like it had been painted with a red oxide primer at some point but no top coat applied.

The drain base was concreted and had some grass breaking through, however was in generally good tidy condition.

It should also be noted, that a few people from SPAB felt it would be good to leave the original patina and just use a protective rust preventing wax instead of painting (<https://www.dinitroldirect.com/product/dinitrol-high-performance-wax>). This would not work particularly well on the stand pipes that have had new parts cast but could work for the one outside Milton Cottage.

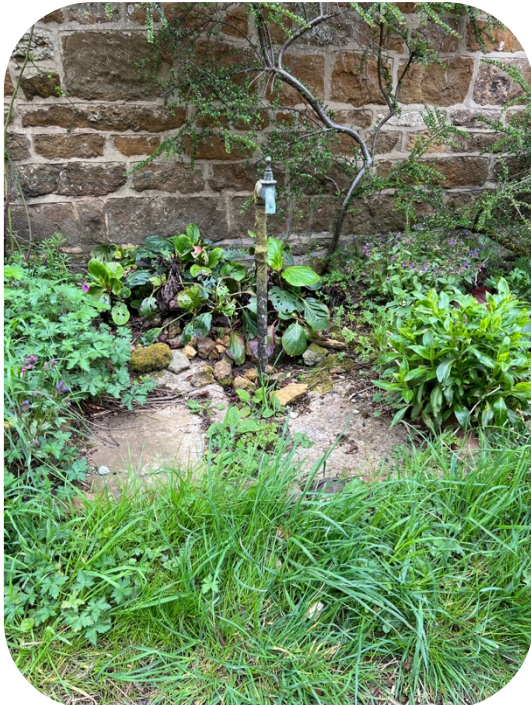
Outside Pump Cottage

Observations:

Unfortunately, there is very little left of the stand pipe apart from the internal feed pipe (capped with a tap) and the drain. A particular shame as the cottage was named after the 'pump'.

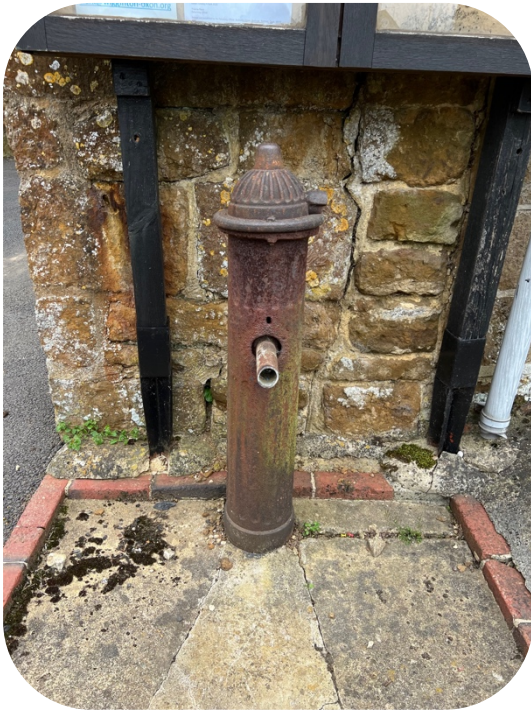
Outside the Bus Shelter / Home Farm

Observations:

Missing external spout (and retaining bolt)
Missing handle and weight
Surface rust

The drain base in generally good tidy condition.

Aluminium or Iron Casting – the missing parts could be remade by sand casting the shapes from a pump that is complete. Luckily for Wigginton, we do have some complete ones. Other villages have had to rely on the goodwill of another villages to loan parts.

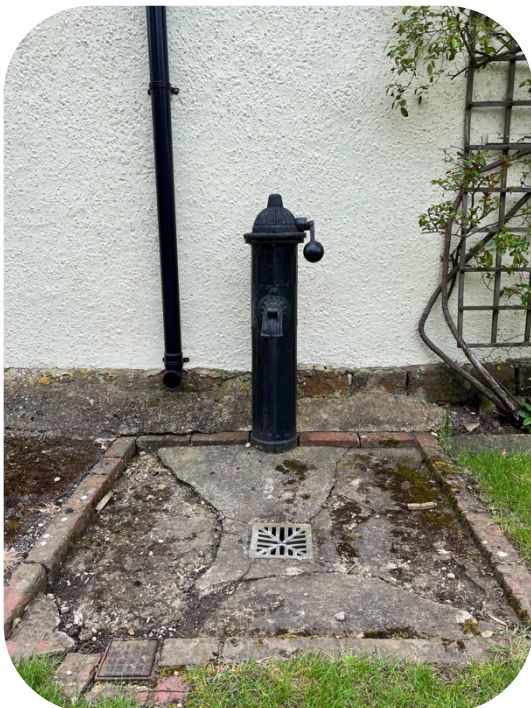
Outside Heronsbridge

Observations:

Stand pipe is complete and in good condition.
Painted black and no rust.

The drain base in starting to deteriorate but good tidy condition.

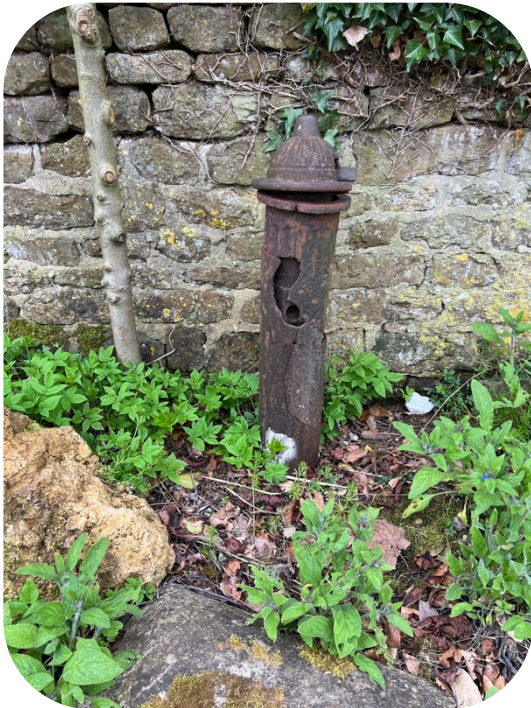
Corner of Mill Lane and School Lane (Heartease)

Observations:

This stand pipe has been hit by a vehicle at some point and has caused the cast iron casing to crack.

The top is loose and missing a bolt.
Internal and external spouts are missing as is the weighted handle.

There is a lot of surface rust.

The base is not visible.

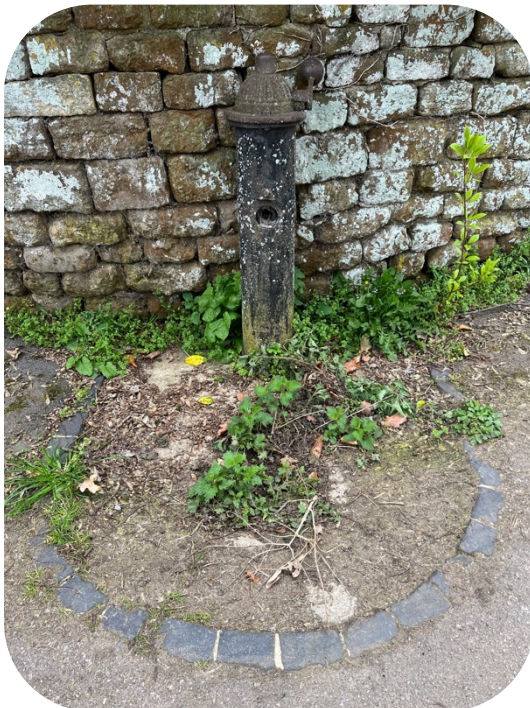
Corner of Mill Lane and Dash Hill Lane (Manor Farm)

Observations:

Missing the internal and external spouts (remnant of external spout still bolted on)

Handle fitted incorrectly and wedged against wall.

Surface Rust.

Base has some weeds coming through, but the surrounding edging is nicely shaped.
